# Hagley Flood Events October and November 2019

**Investigation Report**

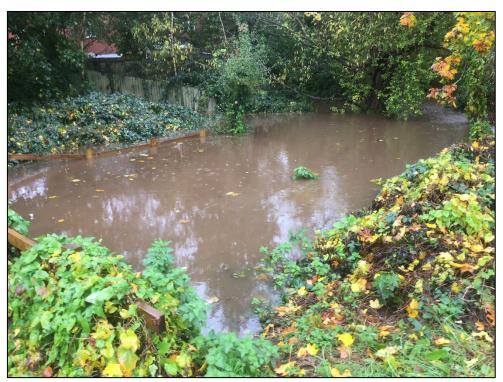
Photo taken during the October flood event looking over the Greenway culvert.

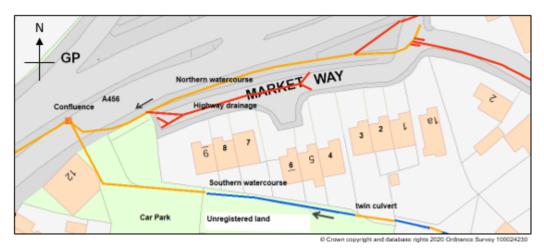
Figure 3. Culverts and watercourses near Market Way

Site visits undertaken by North Worcestershire Water Management and Worcestershire County Council Highways after the event, including examination of the culverts and liaison with residents, suggest that the privately-owned twin culvert caused a local pinch point as the two pipes combined have a lower conveyance capacity compared to other culverts in the vicinity. This was exacerbated during the event by some (but not excessive) silt and debris being present in the vicinity of and within the twin culvert, and possibly debris partially blocking the makeshift trash screen installed at the entrance of one of the two pipes of the twin culvert.

- Replacing the twin culvert at Market Way with a single larger culvert would increase the conveyance.
- Well designed, installed and maintained trash screens in the right locations may help to reduce the risk of culverts blocking in the future.
- Well designed, installed and maintained warning systems will help to reduce the impacts of future flooding.
- An active Flood Action Group with a flood resilience plan developed in liaison with the Parish Council, District Council, County Council, Environment Agency and Severn Trent would help to reduce the impact of future flooding.
- Reprofiling works to the highway or footway in the vicinity of the culvert on Chestnut Drive could enable flood water to flow back into the watercourse without entering properties.

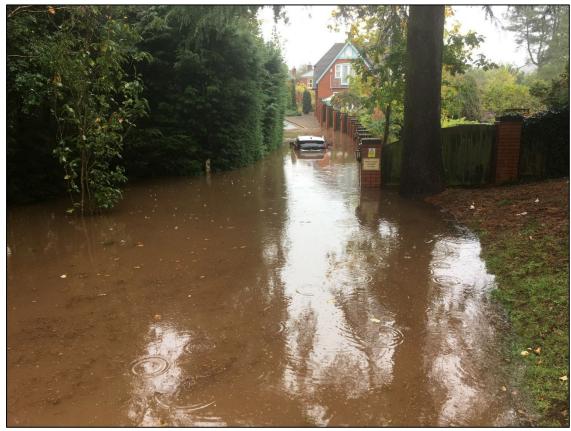
Photo taken during the October flood event from The Oasis access road.

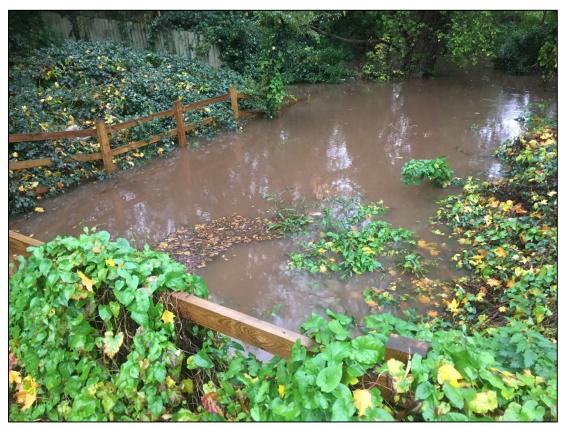
Photo taken during the October flood event looking over The Greenway culvert towards Chestnut Drive.

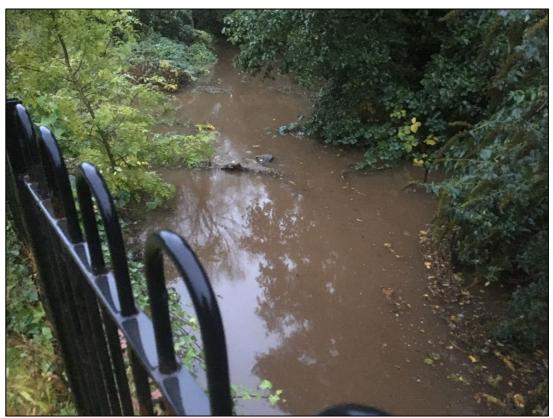
- Highway drainage and sewer infrastructure was in generally good working order although it was overwhelmed by the volume of rain water.
- The blockage in the culvert under Chestnut Drive was a major cause of the flooding in October 2019. This was in part due to debris being left near the river bank and in part due to the sudden reduction in the diameter of the culvert. A similar blockage is likely to happen in the same location in the future unless this is addressed.
- The watercourses are in generally good order, with few obstructions, although they were overwhelmed by the volume of rain water.
- A lack of resources meant that the flood investigations were not complete
  prior to the more severe flooding in February, further delaying the postflood investigations and reporting.

Photo taken during the October flood event looking over the Chestnut Drive culvert towards The Greenway.

• Removing, or at least smoothing, the sudden change in diameter of the Chestnut Drive culvert will reduce the likelihood of blockages in the future.

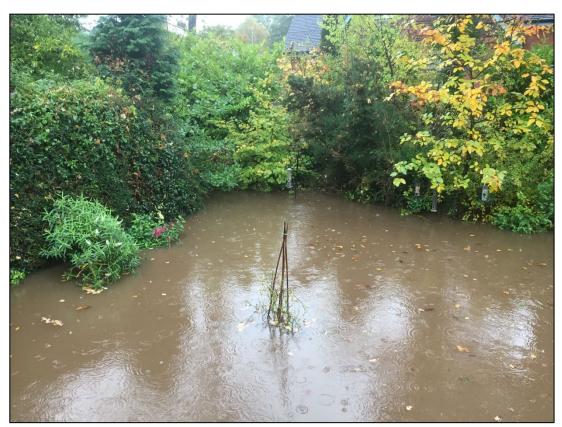
Photo taken during the October flood event – flooded rear gardens in Willow Close.
