Lea Castle Farm, Wolverley, Kidderminster

Stage 1 Road Safety Audit

Client: NRS Aggregates Limited

Reference: PC1790-RHD-ZZ-XX-RP-X-0001

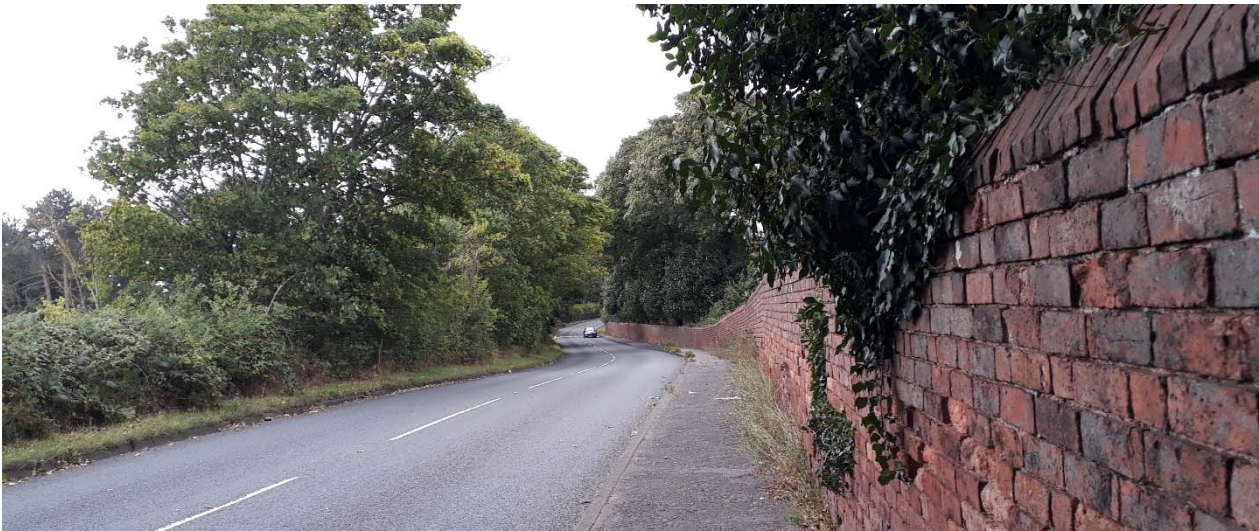
Location: B4189 Wolverley Road, existing brick wall.

Summary: Exposed termination of the removed section of the existing brick wall could result in a higher severity of injury in the event of a collision.

Description: A section of the existing brick wall is to be removed to accommodate the proposed access and required visibility splays. No detail has been provided to the Audit Team on the method of termination of the exposed sections of the wall. Failure to provide adequate measures to protect the exposed ends of the wall from vehicle strikes could lead to a higher severity of injury should a collision occur.

B4189 Wolverley Road looking west towards Sion Hill, showing existing brick wall

RECOMMENDATION

The brick wall should be tapered, similar to the existing vehicle access to Broom Cottage (shown below) to reduce the likelihood of a higher severity of injury in the event of a collision.

Problem 1 – Brick Wall termination at access point.

The Audit Team suggests the provision of tapers to reduce injury severity should a collision with the wall occur. Whilst tapers could be provided, this would result in a greater length of the existing wall being affected by the access creation, in order to maintain the required access width. A further consideration is the potential for the tapers to deflect a vehicle which has left the carriageway and collided with the wall, back towards and possibly into the live carriageway where it could collide with pedestrians on the footway or other vehicles/cycles travelling along the carriageway itself.

Whilst the inclusion of tapers may result in reduced injury severity for the vehicle occupants when colliding with the wall, they could also result in significantly worse injuries to other road users that may be avoided in the absence of the tapers.

It is understood that the Applicant is content to provide tapers to the wall on either side of the access, rather than a straight termination, should that be the Council's preferred option, taking the Audit Team's and foregoing comments into account.

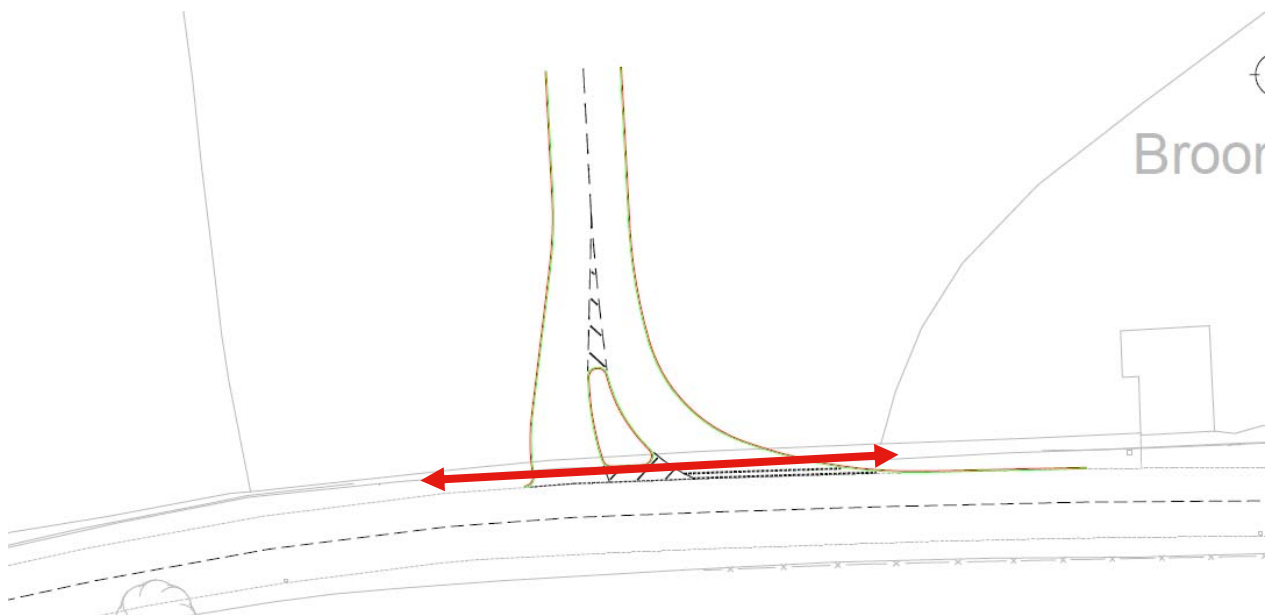
Location: B4189 Wolverley Road/ proposed site access, existing footway.

Summary: Failure to consider pedestrian movement across the junction could lead to pedestrian trips/falls at the kerb face, resulting in injury or collisions with vehicles on the main road.

Description: The proposed access drawing does not provide any pedestrian facilities across the new junction. The width of the junction could result in pedestrians crossing in two movements, waiting either within the hatched markings to the south of the traffic island (at risk of collisions with vehicles on the main road), or on the island itself.

No information has been provided to the Audit Team in relation to the provision of dropped kerbs on the footway approaches to the junction or on the traffic island. Failure to consider pedestrian movement across the junction could lead to pedestrian trips/falls at the kerb face, resulting in injury or collisions with vehicles on the main road.

Extract from The Hurlstone Partnership drawing 'Figure 1', showing pedestrian desire line across the junction

RECOMMENDATION

Provide dropped kerbs and space within the central island for pedestrians to wait safely.

Problem 3 – Pedestrian Crossing Proposed Access

The central island within the site access bellmouth is set-back to a position coincident with the rear of the existing footway, such that the existing desire line and established pedestrian route may be retained. The provision of dropped kerbs at the crossing point, together with tactile pavings to assist the visually impaired, are recommended and will be incorporated into the detailed design package to be submitted for approval and Stage 2 RSA, following the granting of planning permission, in accordance with the normal procedures.
