# Hagley Flood Events October and November 2019

**Investigation Report**

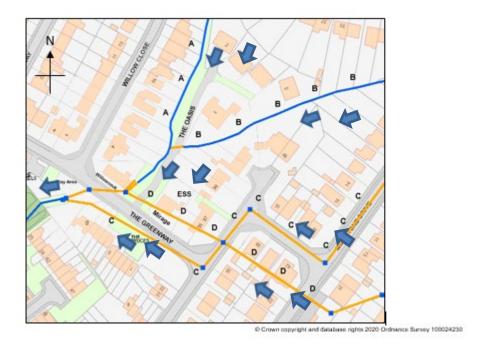
Figure 5. Close-up of watercourses and culverts near the Greenway

The northern arm of the Gallows Brook is labelled 'A'. The first confluence is with the small unnamed tributary (labelled 'B') at The Oasis, which drains a very small catchment area of around 0.06 km² shown in purple in Figures 2 and 4. This watercourse had been dry for decades prior to the early 2000s when South Staffs Water ceased to abstract and utilise groundwater in the area. It then has two confluences with the eastern arm of the Gallows Brook which drains an area of 1.85 km² shown shaded orange in Figure 2. These are marked 'C' and 'D' in Figure 5. Culverts C and D originate from the same watercourse and bifurcate underground near the junction of Worcester Road and Western Road. They remain separate until they cross paths at a manhole chamber on Cavendish Drive and then they flow into the main arm of the Gallows Brook at The Greenway, the confluence of culvert D being underground upstream of The Greenway and the outfall from culvert C is downstream of the road, visible at the area of open space south-east of The Greenway.
