Appendix 24: Analysis of aggregate resources in ECA 24: Bewdley Fringe

ECA Summary for the Third Stage consultation on MLP (Spring 2015):

Resource number: 24/1

Resource name: Blackstone

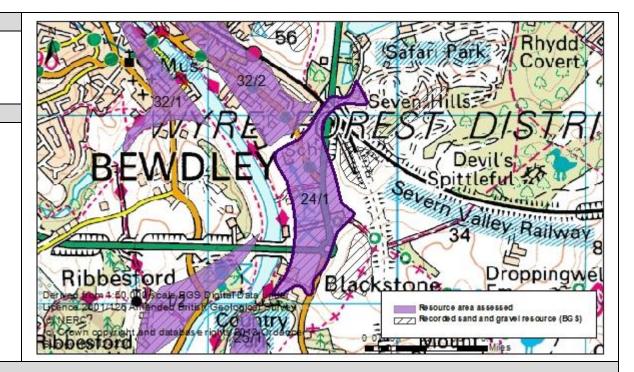
Resource description: A 1st terrace (Powerhouse) sand and gravel deposit. There is no information on thicknesses in the BGS

Commentary: A small resource area intersected by roads and rail with some dispersed development across the resource

Conclusion: Not significant: Small deposit with no information to estimate the resource in this area.
