Lea Castle Farm

Typical Sections through land around Tree 22

KD.LCF.041

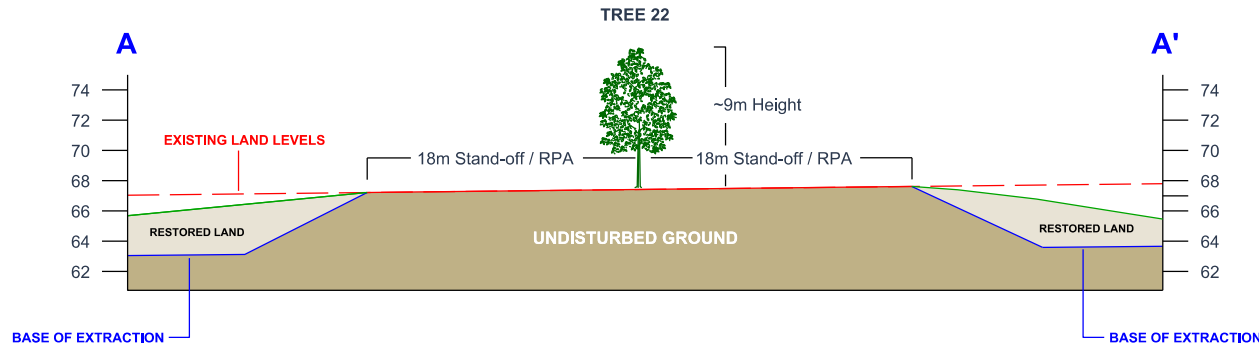
SECTION A-A': West to East Section through Tree 22

T22 - Sweet Chestnut *Castanea sativa*

HEIGHT (m)	STEMS No / Diameter (mm)	STRUCTURAL CONDITION	SURVEY COMMENT
9	1 / 1200	C: Poor S: Poor B: Poor	Tree has apical dieback, stags horns and damaged bark at base.

Note: the tree currently stands isolated within the existing field
